**RE: QUARTERLY PROGRESS REPORT FOR THE AVTEX FIBERS SUPERFUND SITE FOR THE
PERIOD OCTOBER 1 THROUGH DECEMBER 31, 2020 (FOURTH QUARTER)**

SITEWIDE QUARTERLY INSPECTION REPORTS

Quarterly Inspection Report

Quarterly Inspection Report Photographic Log
Avtex Superfund Site
Front Royal, Virginia

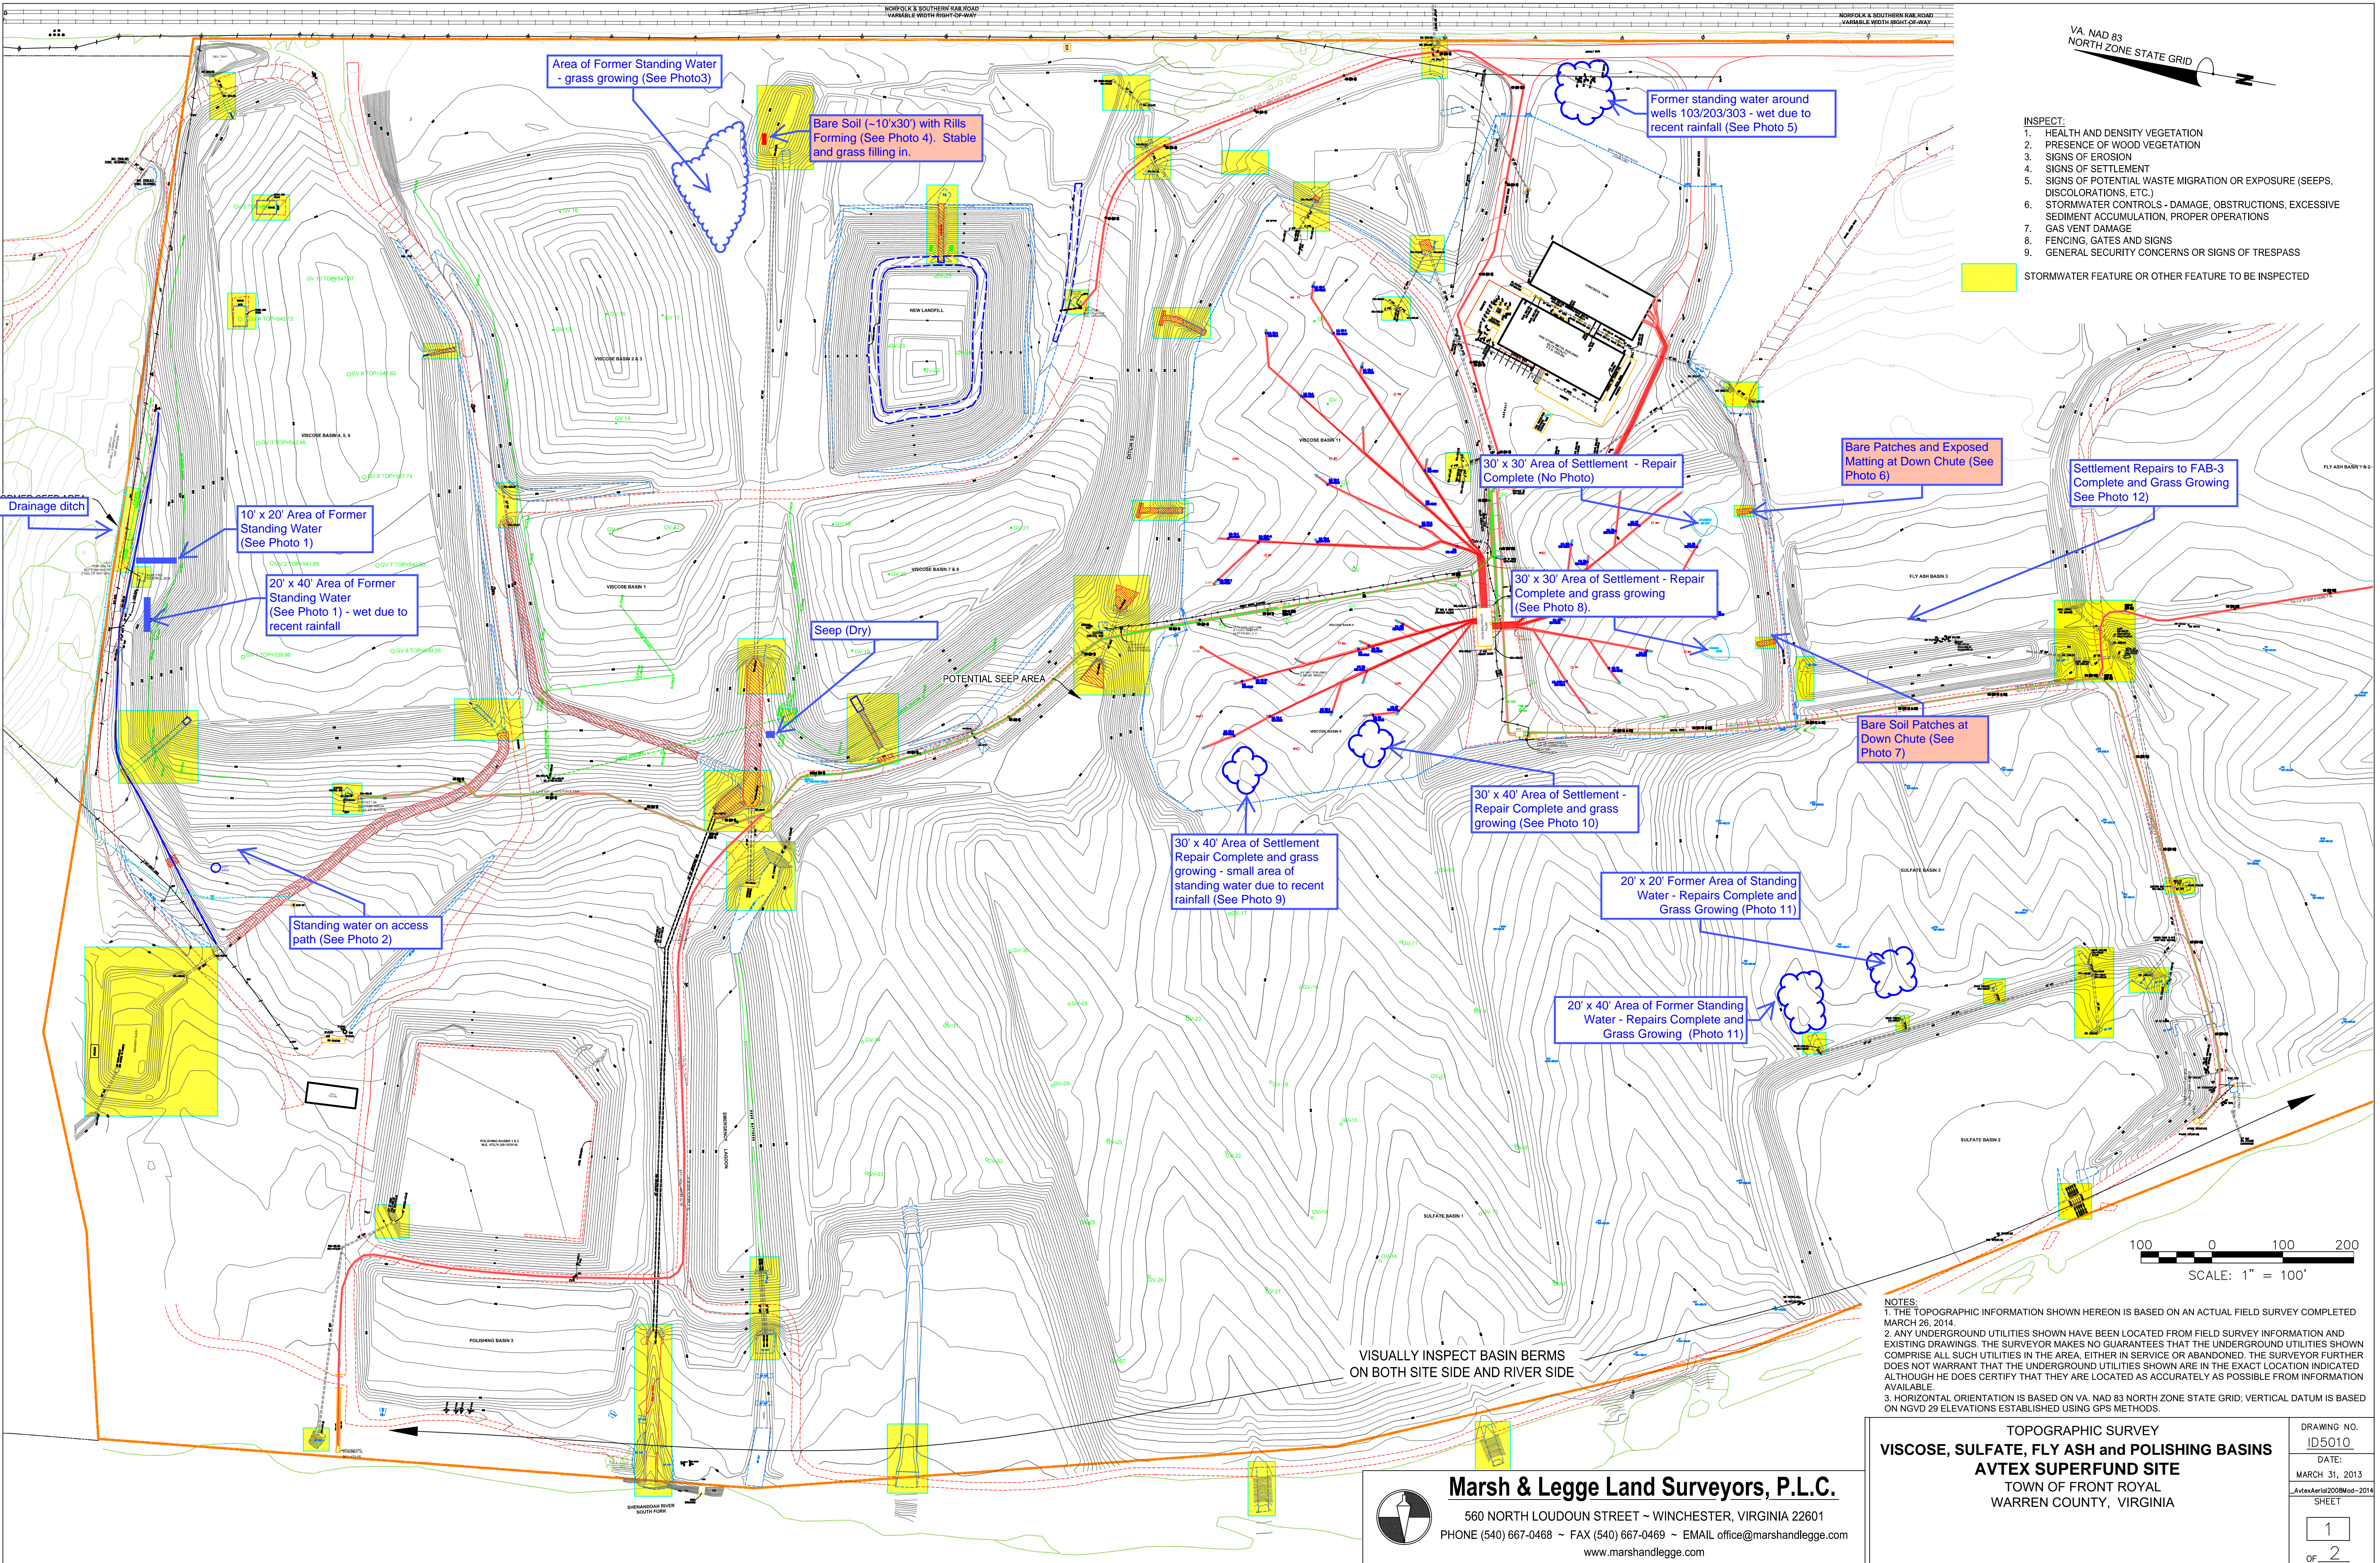
DRAWING NO.
ID5010
DATE:
MARCH 31, 2013
Artesia2008Mod-2014
SHEET
1
OF 2

Questions	Response		Comments and Recommendations
1. Remediation/Restoration Areas			
Is settlement or standing water evident? If Yes, describe the degree of settlement(s) (slight, moderate, significant), record approximate dimensions, and indicate the location(s) on an attached map.	<input checked="" type="checkbox"/> Yes	<input type="checkbox"/> No	Small area of standing water noted on roadway to LS-1. All other areas have been repaired.
Is erosion evident? If Yes, describe the type of erosion (rills, gullies), record approximate dimensions (length, width, depth) and indicate location(s) on an attached map.	<input type="checkbox"/> Yes	<input checked="" type="checkbox"/> No	
Are potential leachate seeps evident or migration of contamination? If Yes, describe the nature (size, color, flow rate), record location on an attached map, and photograph. [Note: Check former seep areas in unnamed tributary north of VB 4-6, check pond area north of VB 9, and check other likely areas (e.g., embankments of VBs, SBs)]	<input type="checkbox"/> Yes	<input checked="" type="checkbox"/> No	See map for locations. Potential seeps: -SE of VB-2&3 (wet due to rain) -NW of VB-7&8 (Dry)

Do landfill/basin embankments show signs of erosion, failure (e.g., cracking, sloughing) or migration of contamination (e.g., seeps, exposed waste)? If Yes, describe the nature (type, size), record location on an attached map, and photograph [Note: Check river-side of embankments along river, if safe to do so.]	<input type="checkbox"/> Yes	<input checked="" type="checkbox"/> No	
Is vegetation distressed or are bare areas evident? If Yes, describe the type of disorder (distressed, sparsely vegetated, bare), record approximate dimensions and indicate location(s) on an attached map.	<input checked="" type="checkbox"/> Yes	<input type="checkbox"/> No	Isolated/minor bare areas noted. See map for locations. With few exceptions, vegetation is filling in.

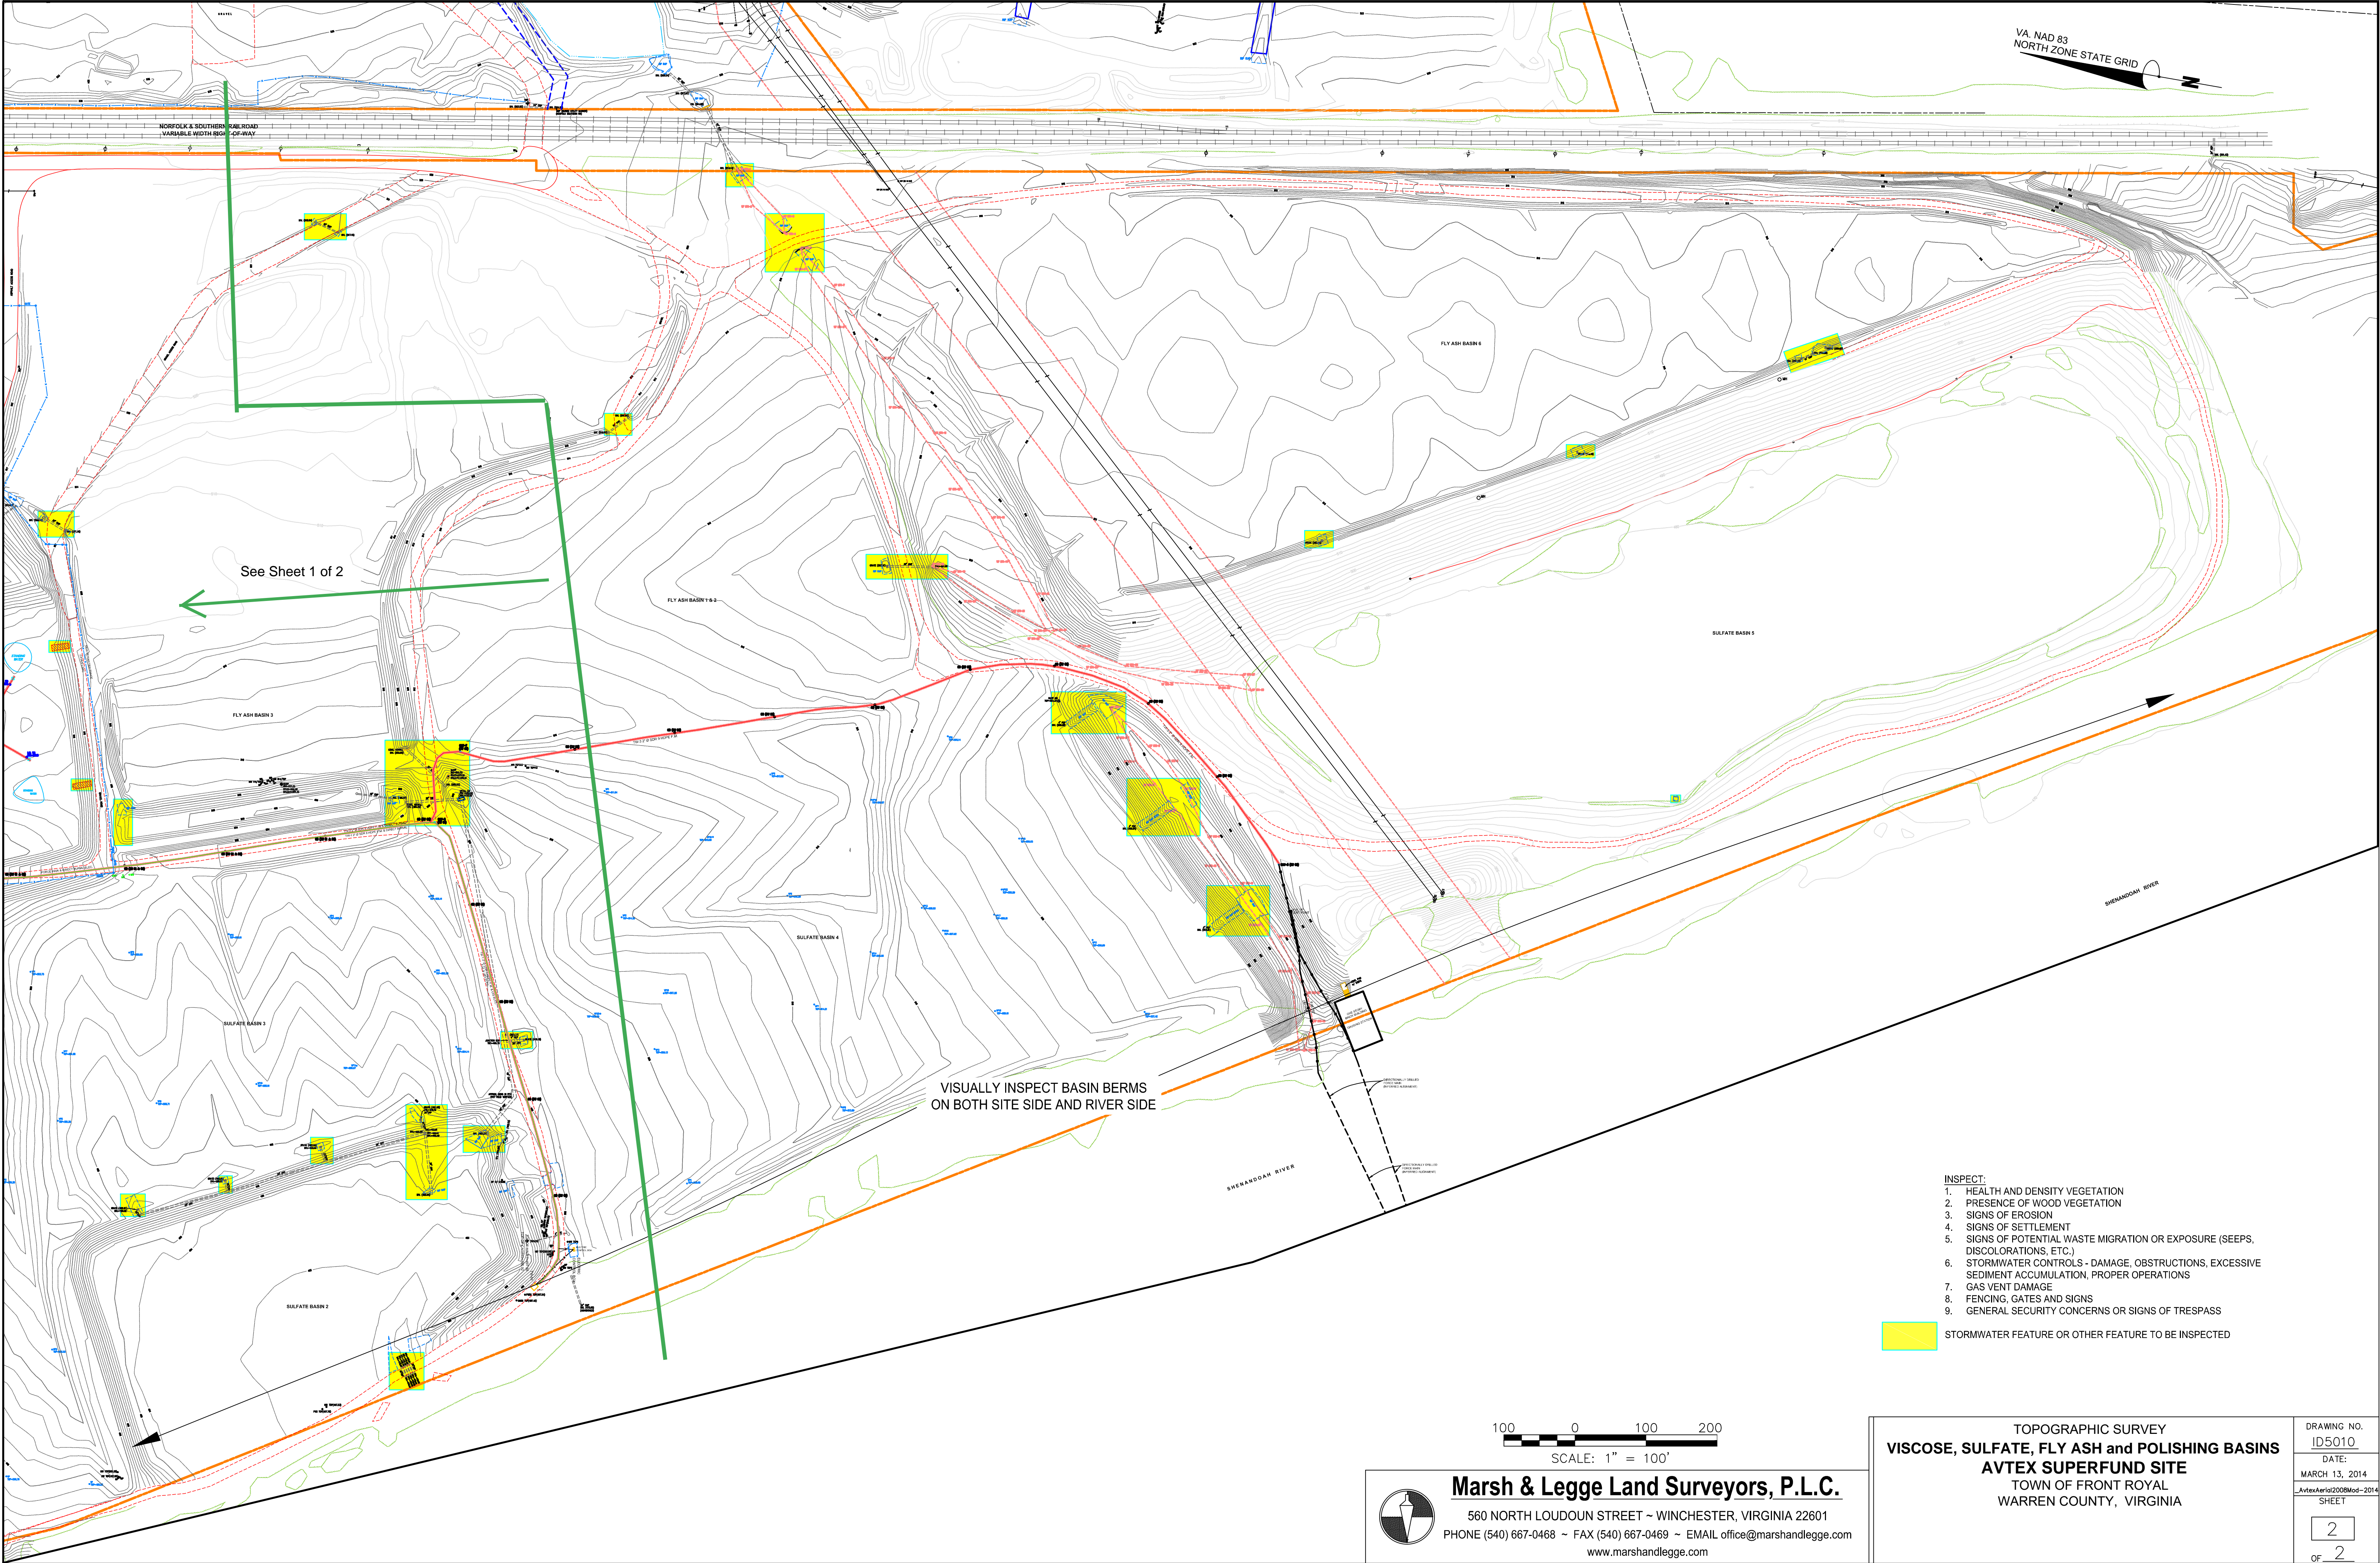
VISUALLY INSPECT BASIN BERMS
ON BOTH SITE SIDE AND RIVER SIDE
